## SCREENING SITE INSPECTION REPORT

**CARR LANDFILL  
BRADNER, OHIO  
OHD 986 966 521**

### FINAL REPORT

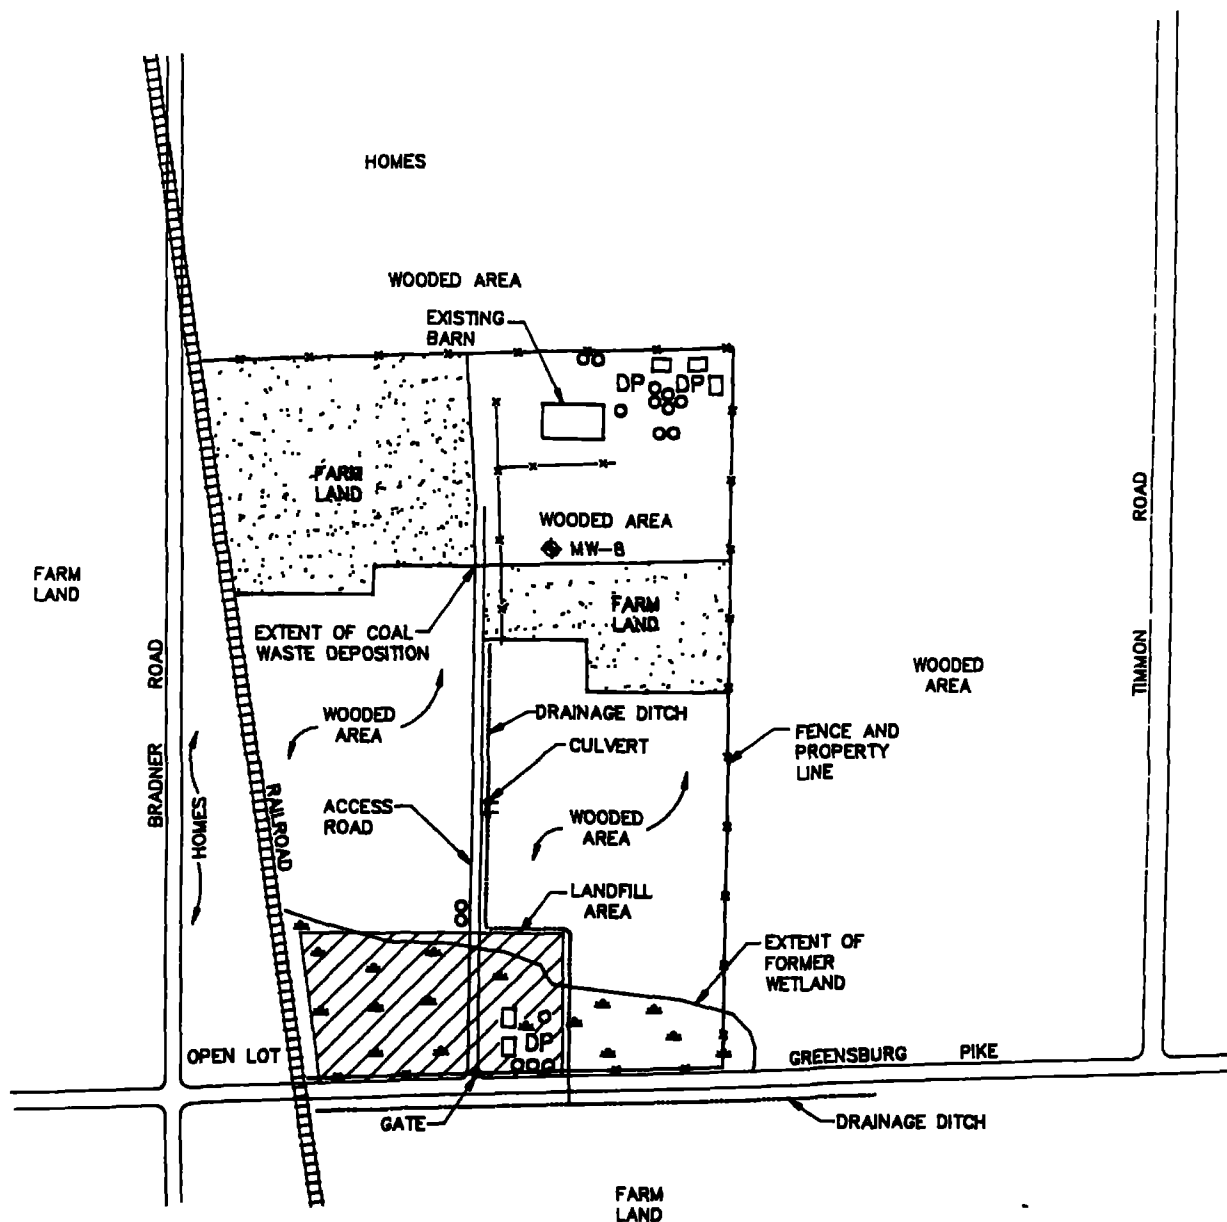
The north side of the property consists of farm land and a barn for livestock (hogs). Approximately 80 yards east of the barn, PRC observed seven 55-gallon drums, several abandoned vehicles, and scrap piles. One drum was labelled "Hanna Chemical Coatings, Hanna Paint Manufacturing, Columbus, Ohio" (Hanna). Most of the drums contained solid material and their labels had rusted off. Near the barn, PRC observed an open 35-gallon drum containing an oily material. Two additional Hanna drums were observed directly north of the barn along the property's northern fence line. One of these drums had an open bung, but both were on their sides, contained solid material, and the labels were legible.

PRC inspected the woods at the property's midsection. Bowser-Morner indicated three monitoring wells exist in the woods, but PRC was only able to locate the well east of the access road. Based on a thorough inspection of the areas where the other two monitoring wells were installed, it appears that either these wells were removed or the well casings were flush-mounted. The site owner was not able to locate the wells. PRC observed two open, bulging drums similar to the other green Hanna drums at the south end of the woods on the west side of the access road. One had an open bung, both were on their sides, contained solid material, and the labels were illegible.

The access road is constructed of limestone gravel. PRC located the culvert that had been replaced with limestone gravel during previous removal activities. This gravel extends approximately 5 feet east of the culvert. The culvert drains the west side of the property into a drainage ditch that runs along the east side of the access road.

PRC observed the 4-acre landfill area. It is composed mainly of construction debris and stones. The area east of the access road has been graded by a bulldozer and farm machinery. Other debris has been placed on the road. At the south end of the landfill, PRC observed several more drums, one of which had a spigot on it and appeared to have been burned. The landfill is bordered on the north and east by woods, on the south by Greensburg Pike, and on the west by the C & O Railroad. The west side of the landfill is composed of hills of asphalt blocks that are becoming vegetated. PRC did not observe wetland vegetation or obvious wetland conditions anywhere on site.

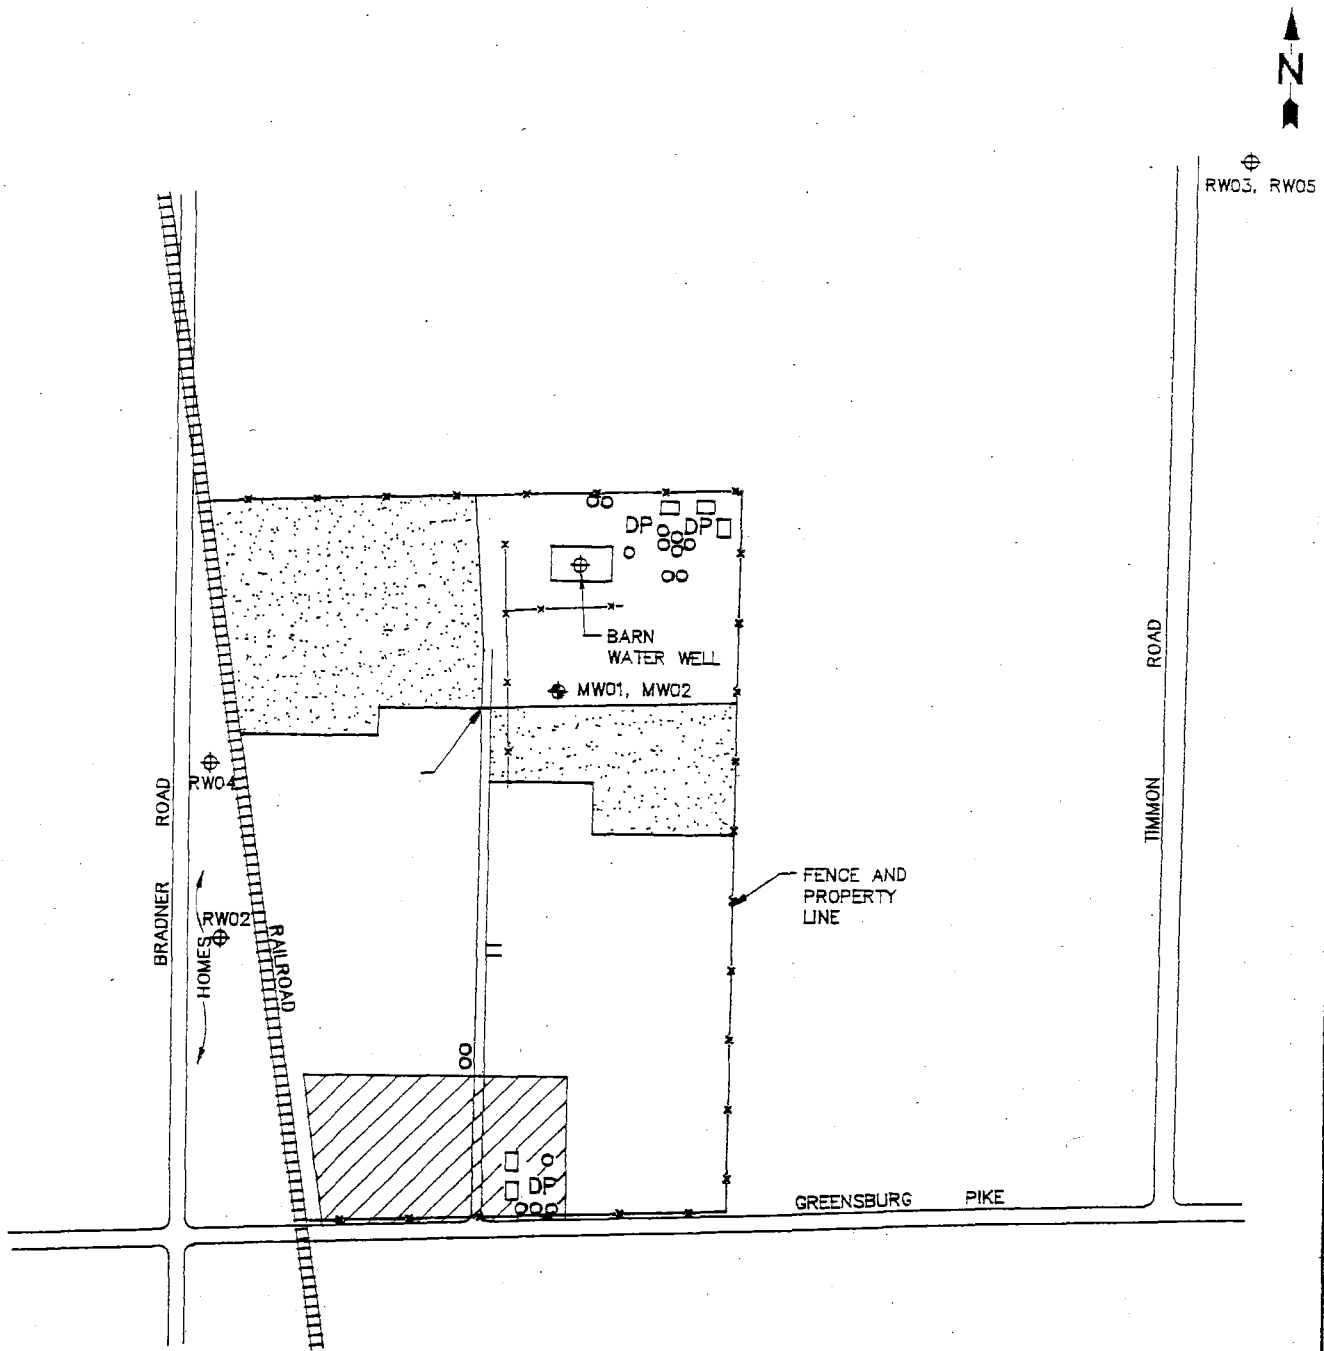
Residential well samples RW02 and RW04 were collected west of the Carr property from households on the east side of Bradner Road. These locations were selected because of their proximity to the site and their potential to be downgradient of the site. The resident from whose well sample RW04 was collected indicated the well is 90 feet deep. Based on the geology of the area and well log (see Appendix C, well logs 1 and 2), these wells are screened in the bedrock aquifer.

Residential well samples RW03 and RW05 were collected from a household well approximately 2,000 feet northeast and upgradient of the site. Sample RW05 was a duplicate sample of sample RW03. The resident indicated that the well is approximately 60 feet deep. Based on the geology of the area, this well is most likely screened in the bedrock aquifer.

PRC collected monitoring well samples MW01 and MW02 from the on-site monitoring well on the north side of the property. Sample MW02 was a duplicate sample of MW01. The well is approximately 9.5 feet deep (Bowser-Morner, 1987a). Depth to water in the well at the time of the sampling visit was about 5 feet. The inorganic fractions of these samples were filtered with a peristaltic pump and filter paper having a pore size of 0.45 microns. Monitoring well samples were collected to determine if hazardous substances have been released to the ground water from the Carr site. See Figure 3 for monitoring well sample locations.

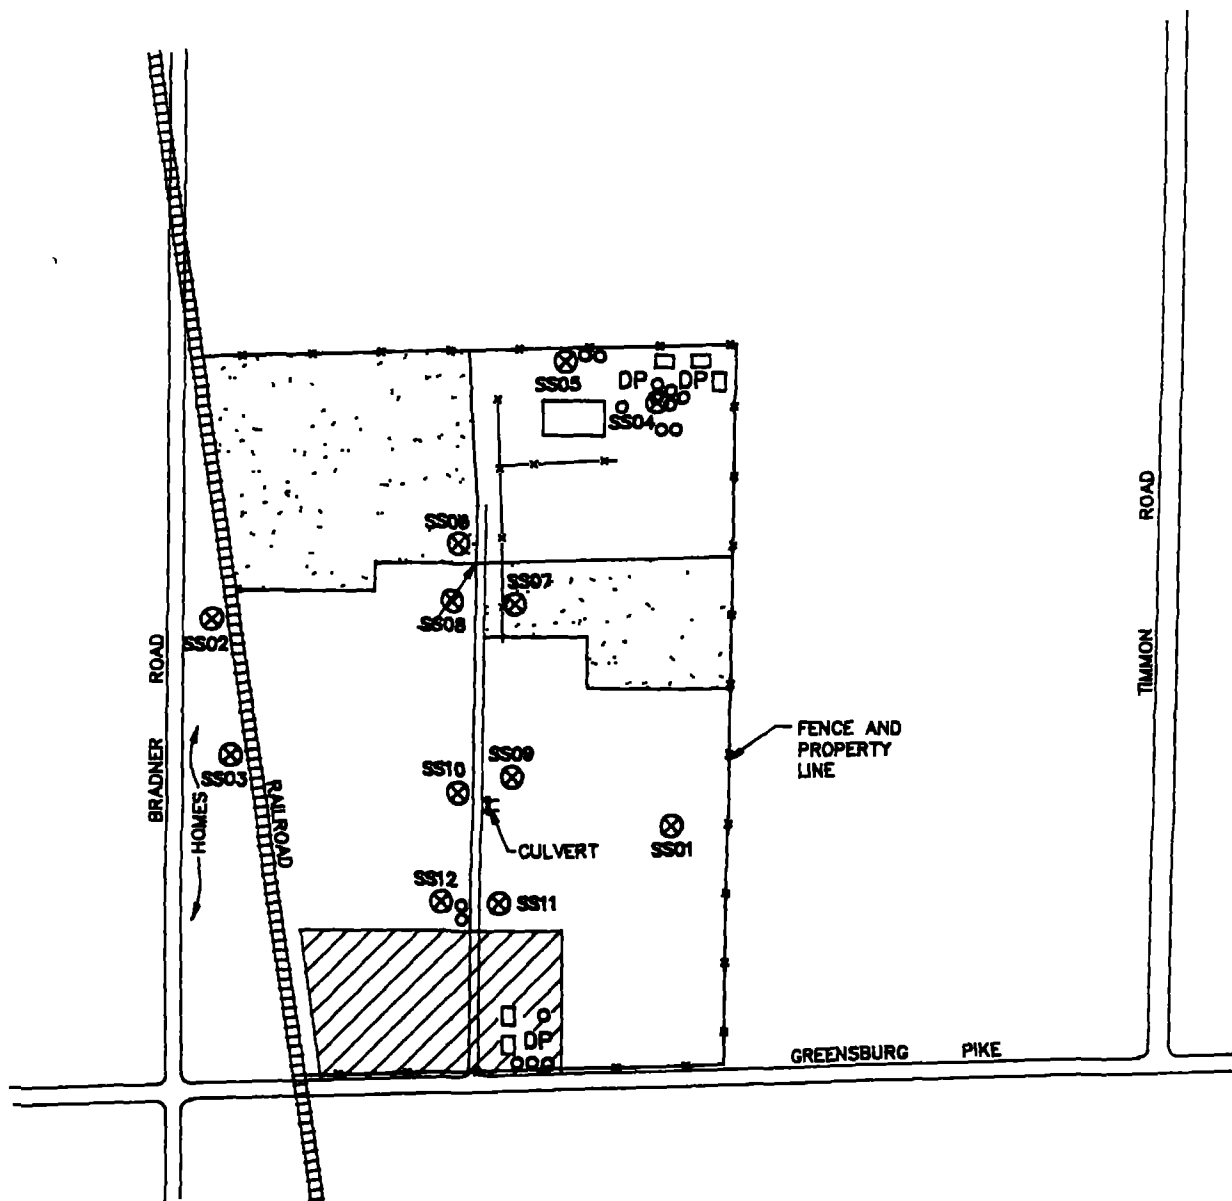
PRC collected two off-site soil samples and 10 on-site soil samples during the sampling visit. Soil samples from off-site residential locations were collected to determine whether contaminated particulate matter has blown off site to nearby properties. On-site soil samples were collected to identify hazardous substances associated with wastes deposited on site and to document the extent of contamination. See Figure 4 for soil sampling locations.

Soil samples SS02 and SS03 were collected off site from residences located due west of the property on the east side of Bradner Road. These locations correspond with residential well samples RW04 and RW02. Approximately 3 inches of snow covered the ground at the time of collection. This snowcover prevented the ground from freezing, which aided in sample collection. These samples were collected between 2 to 4 inches bgs. SS02 and SS03 were collected to identify whether residential surface soils have become contaminated by windblown particulates at the site.

Soil samples SS04 and SS05 were collected near the drums located east and north of the barn. Samples were collected from locations near drums containing solids and that had holes

rusted in them. Samples were collected a few inches from each drum between 2 to 4 inches bgs. The sampling team noted organic gasoline-like odors while collecting soil sample SS05. These samples were collected to identify hazardous substances associated with drum contents.

Soil samples SS08 through SS12 were collected along and on alternate sides of the access road. These samples were collected to identify hazardous substances present at the site. Even-numbered samples were collected on the west side of the access road, and odd-numbered samples were collected on the east side of the access road. All samples were collected outside the limestone fill area between 2 and 6 inches bgs.

Soil sample SS12 was collected by the two rusted drums containing solids located 20 yards north of the landfill. This sample was collected to identify hazardous substances that may have leaked from the drums.

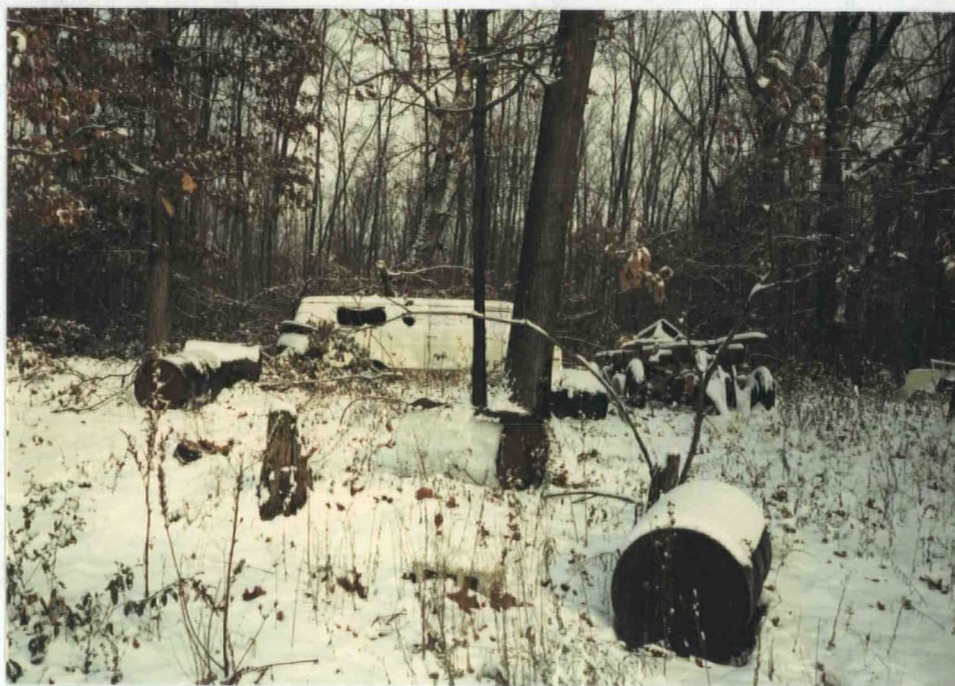
Photograph No.: 1

Location: Barn area

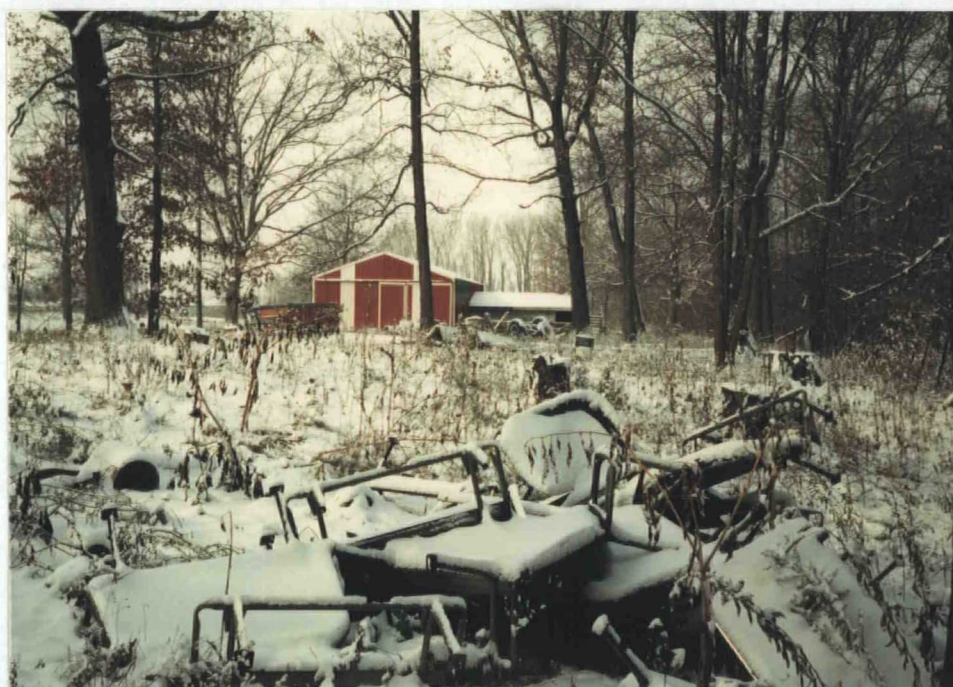
Photograph No.: 2

Description: Scrap piles consisting of steel and plastic objects

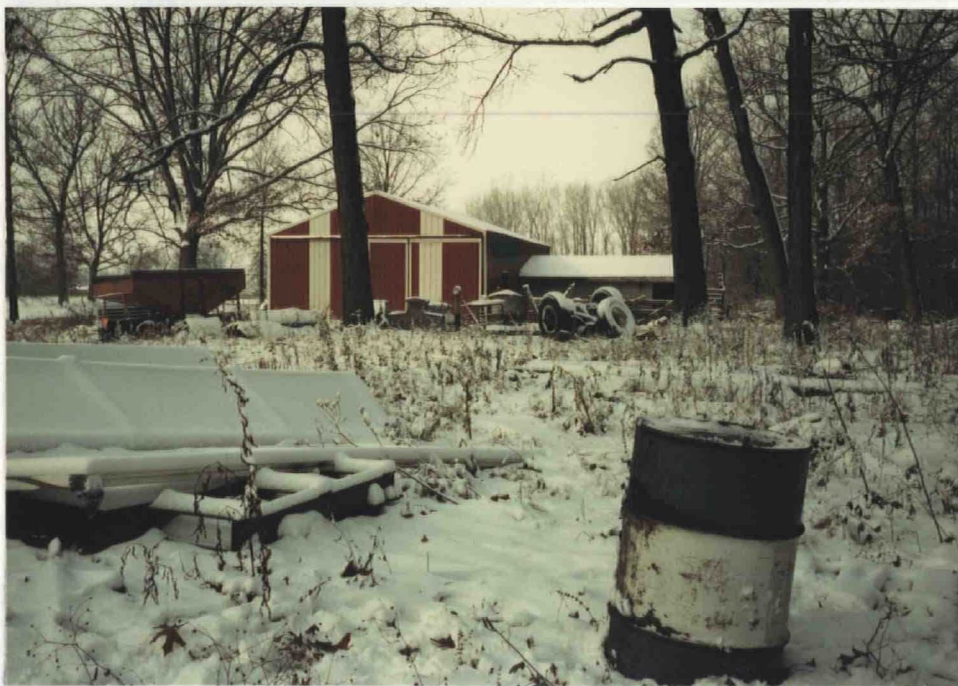
Photograph No.: 3  
 Orientation: West  
 Description: One open 35-gallon drum containing oily material

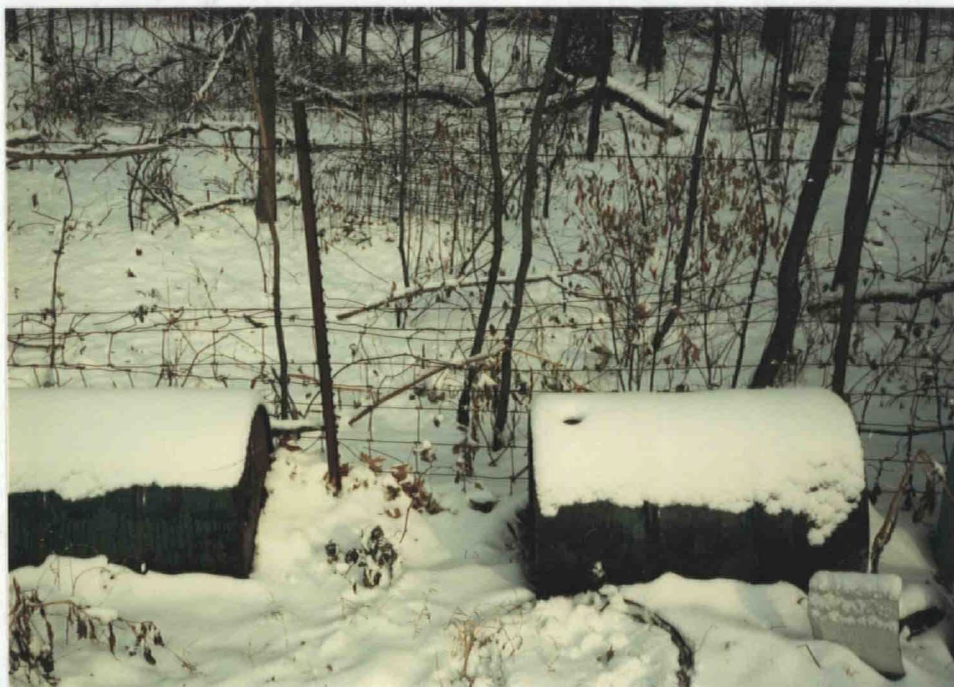
Photograph No.: 4  
 Orientation: North  
 Description: Two green drums on their sides, with white lettering, containing solid material, one of which was open

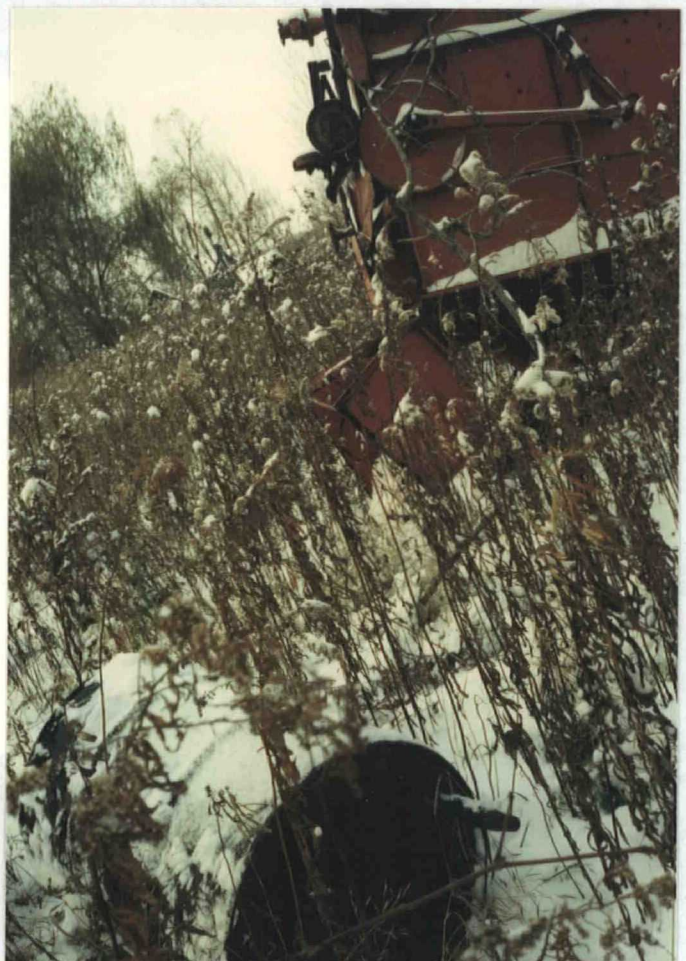
Photograph No.: 8

Description: One drum with a spigot, the bottom of which appeared to have been burned

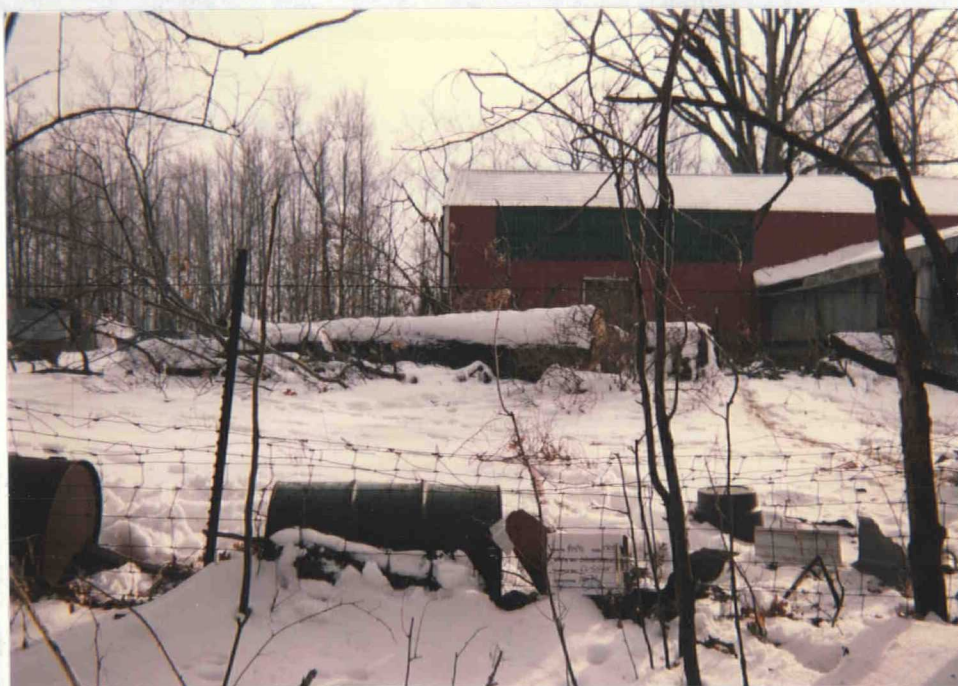
Photograph No.: 26

Description: Perspective view of soil sample SS05 location; the barn is in the background; note the condition of the fence

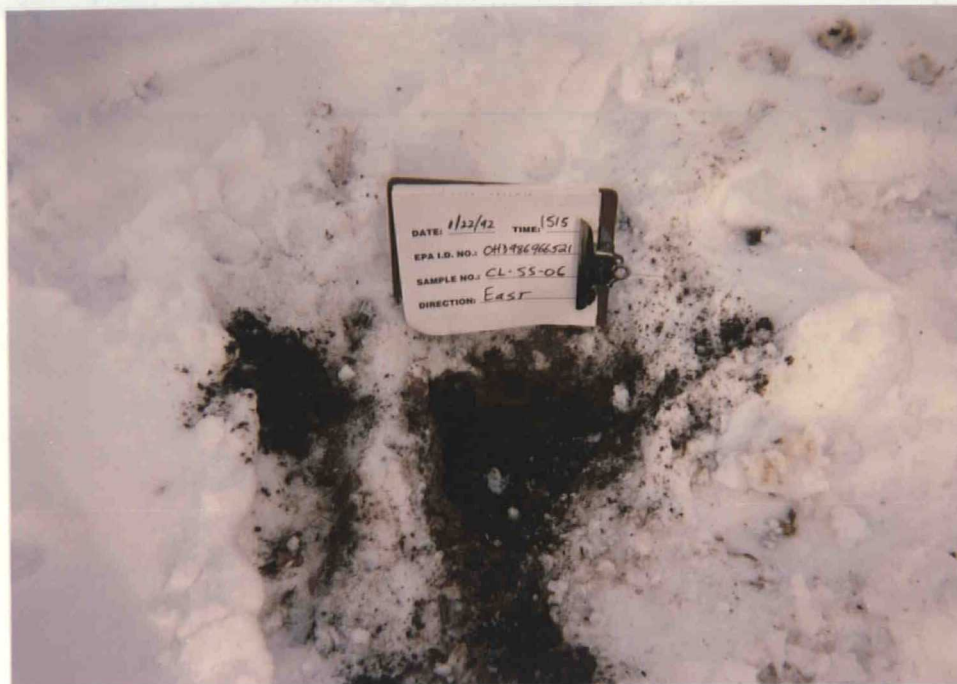
Photograph No.: 27

Description: Close up view of soil sample SS06 location; this is located in the farm land west of the access road, and due north of the northernmost point of coal waste deposition

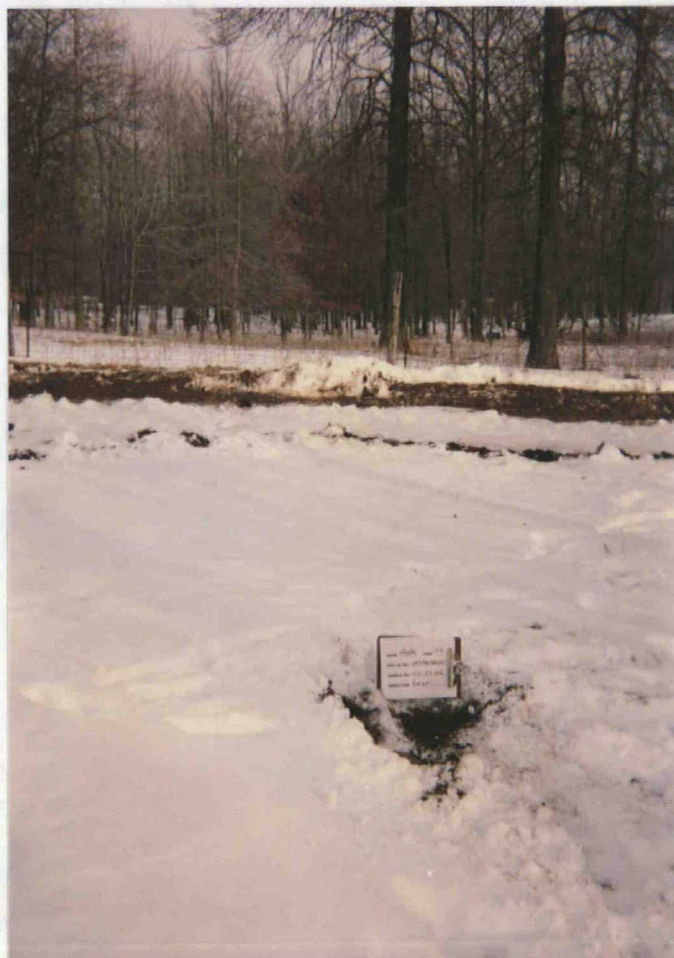
Photograph No.: 28

Description: Perspective view of soil sample SS06 location; the access road is approximately 20 feet away at the dark line near the photo's center

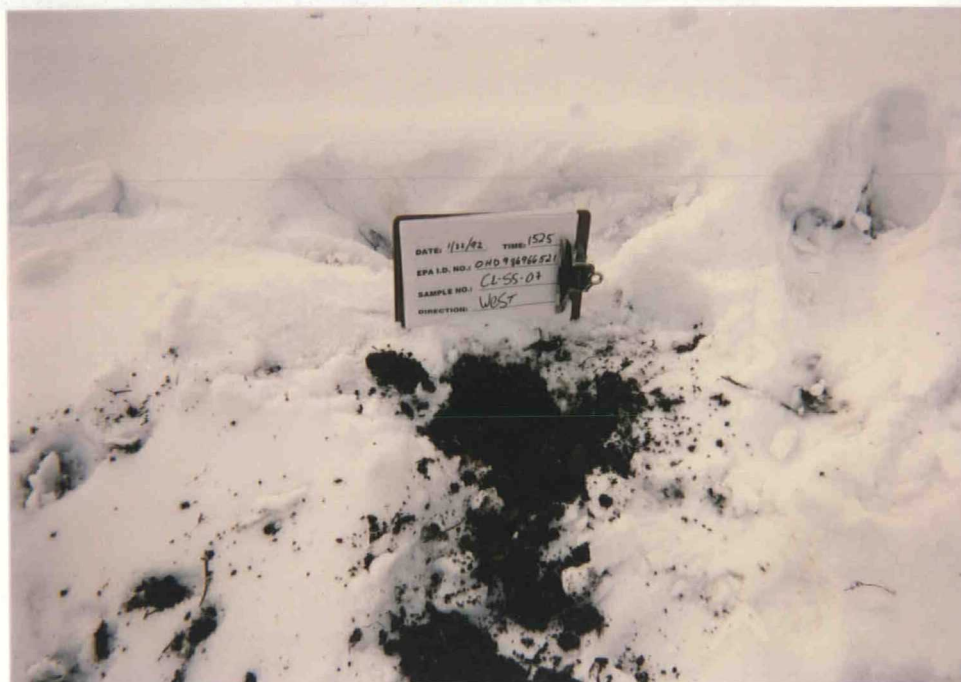
Photograph No.: 29

Description: Perspective view of soil sample SS07 location; automobile marks access roads location, approximately 20 yards away

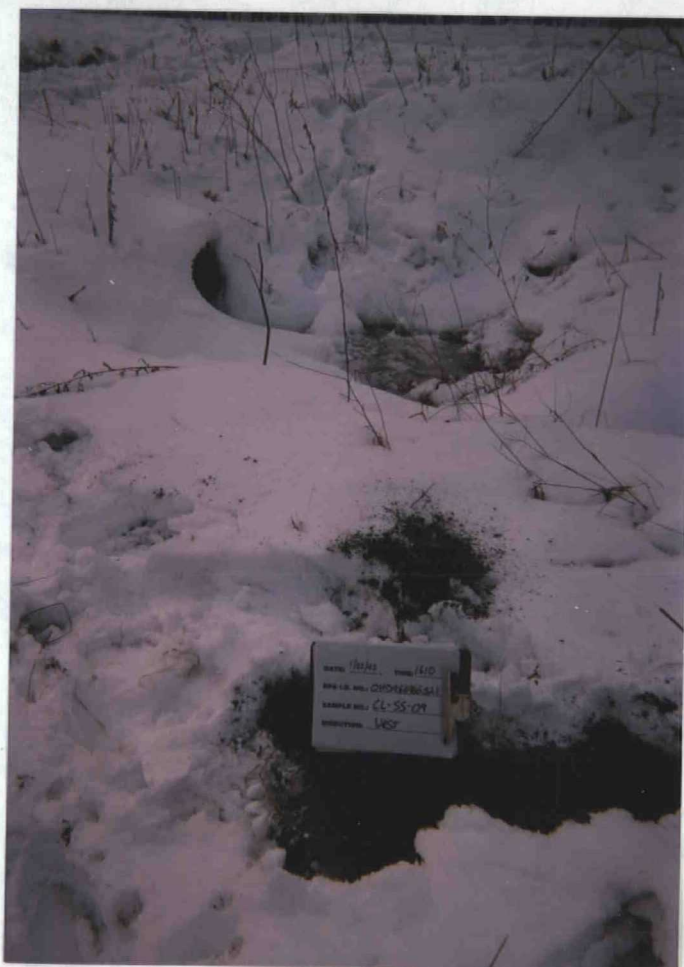
Description: Perspective view of soil sample SS09 location; drainage ditch and culvert are in the background, approximately 4 feet away
